RESEARCH ON STRESS MONITORING OF CRACKED STEEL BOX GIRDER BASED ON SELF-MAGNETIC FLUX LEAKAGE

Abstract

Steel box girder, self-magnetic flux leakage, stress monitoring, crack

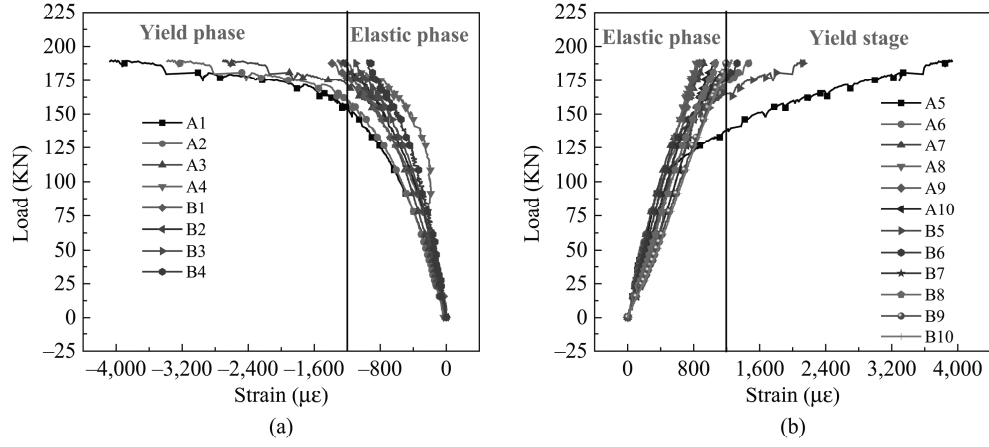
Figure 10. Specimen load–strain curves: (a) compression zone and (b) tension zone.

The detected strain values at the measuring points during the loading process were analysed, and the corresponding load–strain curves in the compression zone and the tension zone were plotted (Fig. 10).

It is evident that the time of entering the yielding stage in A and B sides was different, resulting in an uneven force on both sides and early failure on one side, and this phenomenon weakened the overall bearing capacity of the steel box girder.

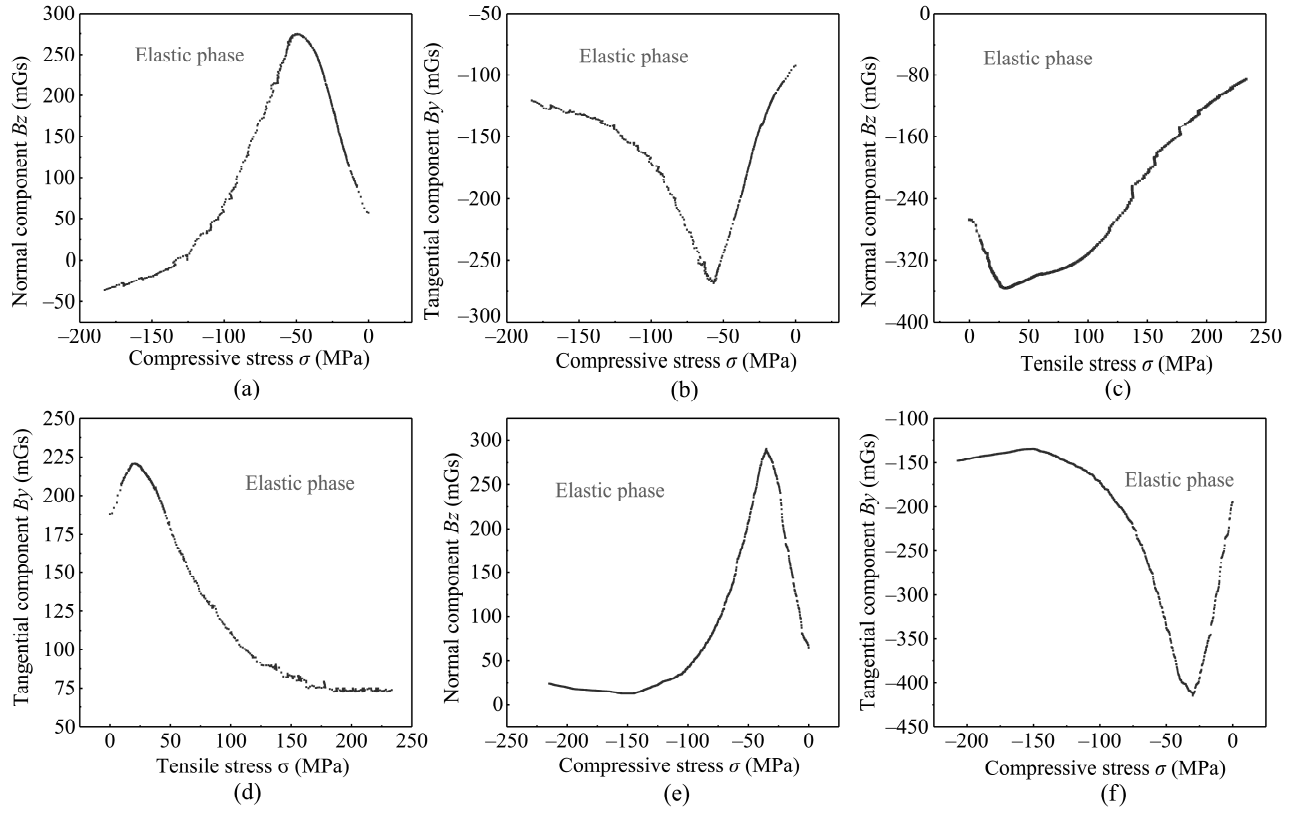
Figure 13. Variation between magnetic signals and stress values at each measuring point: (a) normal component at C1; (b) tangential component at C1; (c) normal component at C2; (d) tangential component at C2; (e) normal component at C3; and (g) tangential component at C3.

To reveal the relationship between the normal and tangential components of the leakage magnetic field strength and the stress values at the magnetic signal measuring points C1, C2, and C3, the leakage magnetic field strength components and the corresponding stress values are assigned

to the vertical axis and the horizontal axis of Fig. 13, respectively.

The magnetic signal measuring point C1 was located in the compression zone under the crack side of the steel box girder. With the increase of the compressive stress, the absolute values of the normal (B_z) and tangential (B_y) components increased. After the compressive stress reached 50 MPa, the absolute values of the normal and tangential components gradually decreased and tended to be gentle. The magnetic signal measuring point C2 was located in the tension zone of the steel box girder web. The absolute values of the normal and tangential components first increased and then decreased, and a prominent inflection point appeared when the tensile stress was 30 MPa. The magnetic signal measuring point C3 was located in the compression zone under the roof of the steel box girder, which always existed in the elastic phase. The absolute values of the normal and tangential components first increased, then decreased, and eventually tended to be flat, and a prominent inflection point was formed when the compressive stress was 40 MPa.

Therefore, the magnitude of the magnetic flux leakage signal first increased with the increase of the stress value; however, when the stress value exceeded a certain point, it decreased with the increasing stress. When the stress was 30–50 MPa, the stress magnetic signal curve had an obvious inflection point, and a very complex non-linear relationship was noticed between magnetization and stress.

The obtained test results were consistent with the findings of the magneto-mechanical theoretical effect model. At the beginning of the elastic phase, the magnetic memory signal weakened the geomagnetic field. To overcome the initial-state instability within a certain loading range, the magnetic memory signal manifested a local enhancement phenomenon. In the later stage of the elastic phase, the external load generated stresses in different parts of the specimen. The stress weakened the magnetic flux leakage signal strength and, finally, approached the hysteresis state; therefore, the magnetic memory signal intensity decreased with the increase of the stress value. As the steel plate at the measurement point of each magnetic signal had just entered the plastic phase, the relationship between the stress and the magnetic signal in the plastic phase was not obvious; hence, the relationship between magnetization and stress at this stage was more complicated.
